ElectriCheck

Visual inspection report

ElectriCheck — Visual Inspection

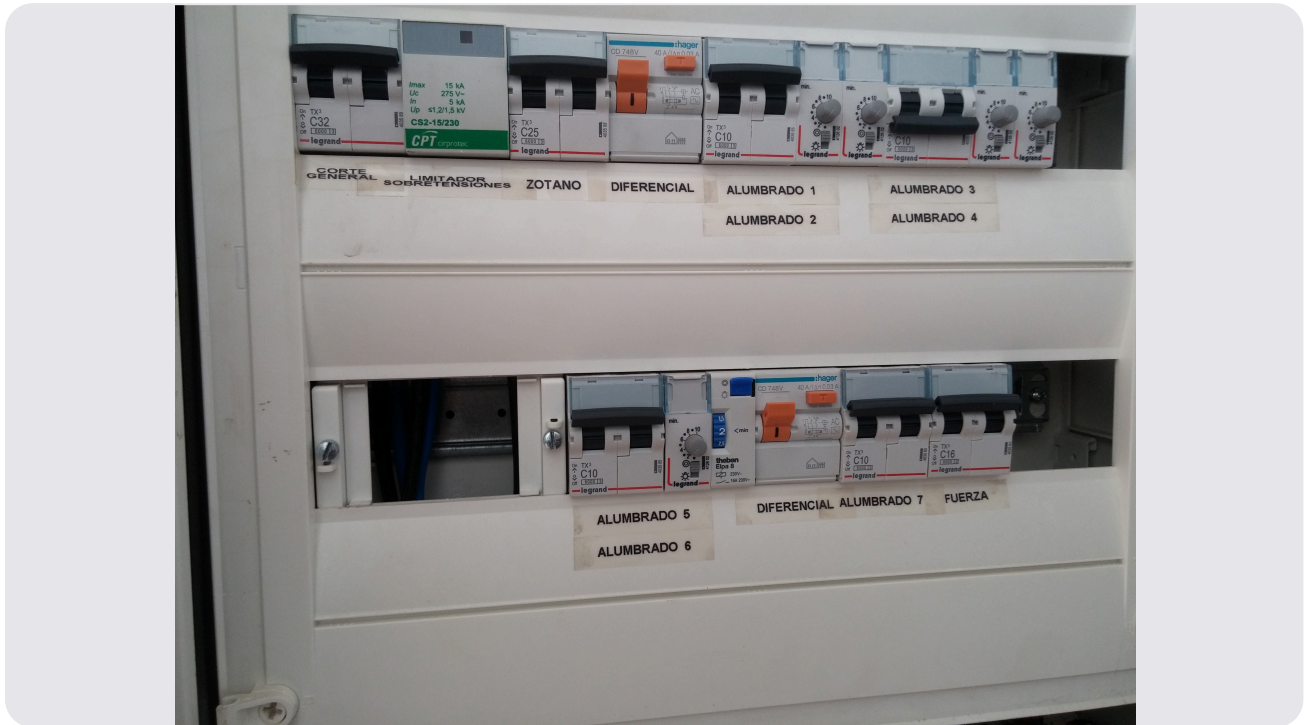
The image shows an open electrical distribution board with various protective devices and wiring visible.

Observation — Exposed Internal Wiring

What is visible: On the lower left side of the distribution board, there is an open section where internal wiring and components are directly visible, without a cover or blanking plate.

Why it may matter: Direct access to internal electrical components could lead to accidental contact.

Observation — Inconsistent Labelling

What is visible: The labels for the circuits appear to be handwritten on tape and are not consistently aligned or formatted. Some labels are partially obscured or appear to be peeling.

Why it may matter: Clear and durable labelling is helpful for identifying circuits and devices, which can be important for maintenance or in situations where circuits need to be quickly identified.

- Exposed internal wiring and components in the lower left section.
 - Inconsistent and potentially deteriorating circuit labelling.
-

Suggested on-site check: Verify that all openings in the distribution board are properly covered or blanked off to prevent access to internal wiring.

Suggested on-site check: Review and update all circuit labels to ensure they are clear, accurate, durable, and consistently applied.
